Report & Quote

We are pleased to provide you with the following Report and Quote for the repair of your Gearbox model D123-789 s/n 555 with a 25.59:1 ratio as follows:

Failure Analysis Report

Failure Analysis Photo Report

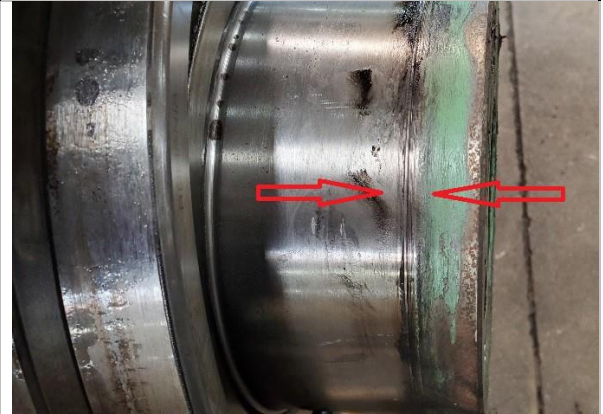
Low speed seal area have excessive wear.
 We recommend weld and repair of the low speed seal area to restore correct housing size.

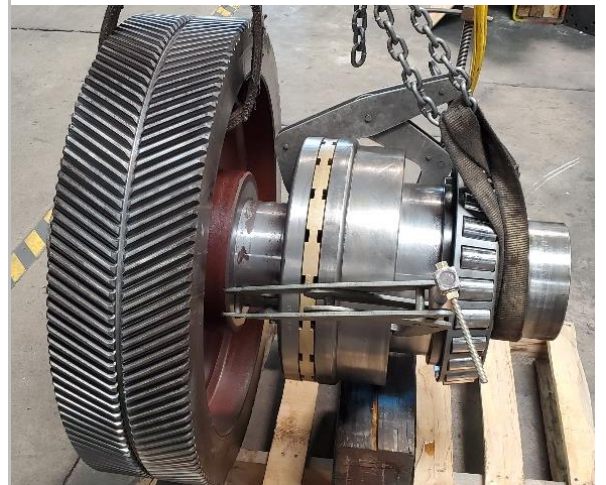
Low speed and high speed gear sets show very little wear.
 We recommend clean and reuse.

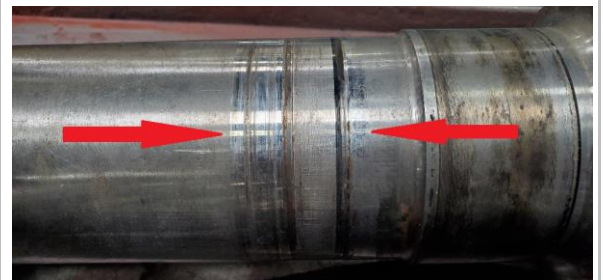
High speed seal area have excessive wear.
 We recommend weld and repair seal area to restore correct shaft size.

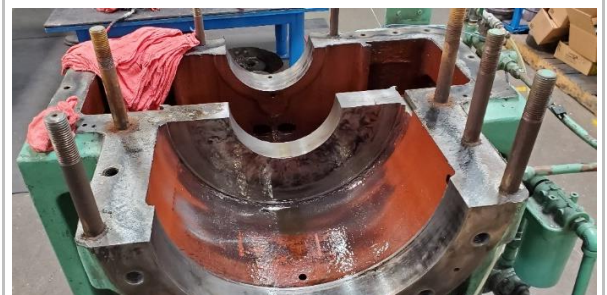
All bore dimensions were measured and found to be within correct size tolerance. The housing shows minimal wear and may be reused with minor repairs.
 We recommend powerblasting to clean case, repair of (20) threaded holes and enamel painting of interior to prevent rust.
