Report & Quote

We are pleased to provide you with the following Report and Quote for the repair of your Gearbox model D123-789 s/n 555 with a 25.59:1 ratio as follows:

Failure Analysis Report

Failure Analysis Photo Report

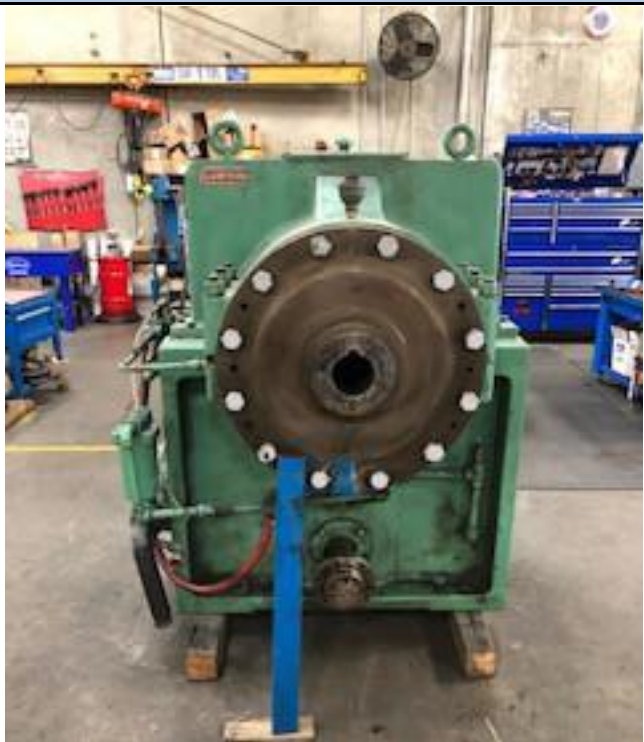
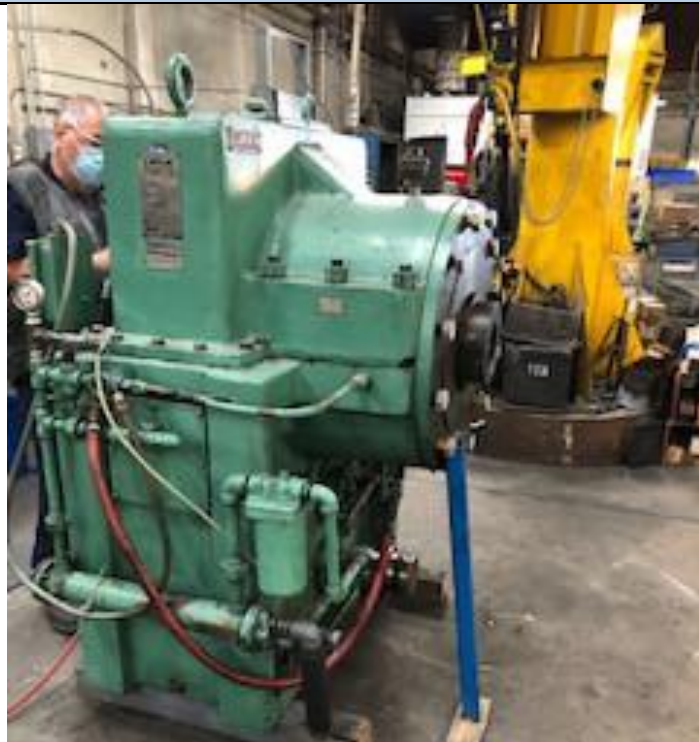
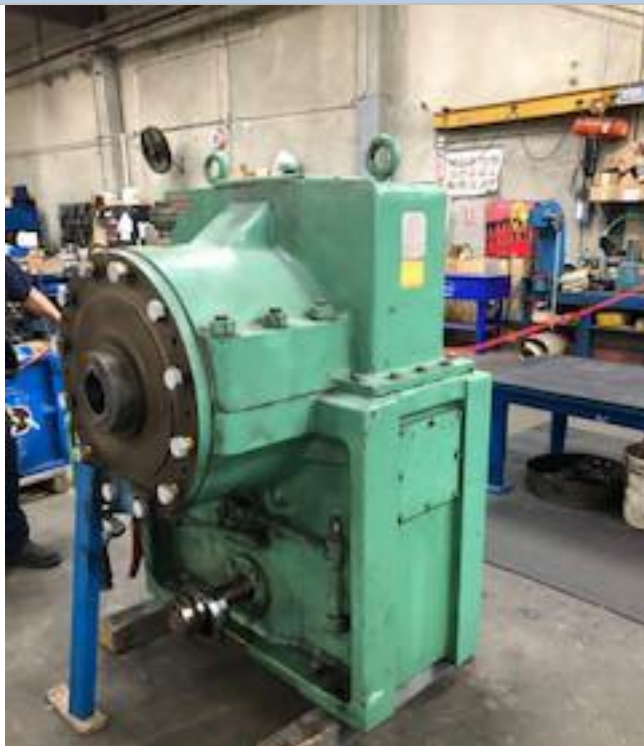
Incoming Inspection Photos

We advise you that the gearbox shows signs of wear and some damage as outlined below. The gears and case are in good condition and may be reused if cleaned up and requalified. We recommend replacing all bearings & seals, the heat exchanger, the pressure gauge, the oil sight and bypass relief valve all to be replaced with new. Gearbox will be reassembled with proper bearing endplay and backlash. Repaired parts include the welding and machining of the low speed and high speed shafts to restore original size and prevent leaking.
